SUBJECT Seat Heaters Too Hot or Too Cold

Cooper, Cooper S

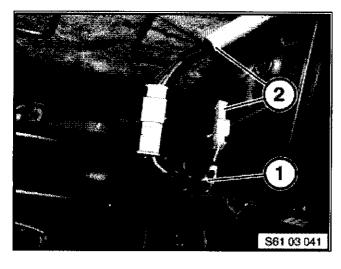
Locate and disconnect the white connector for the seat heater (1).

Adjust the seat to the full forward, full up position, and fold the backrest forward.

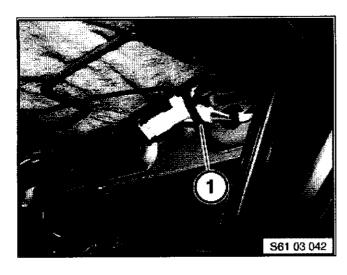
Install adapter cable (1) into existing harness (2).

Loop the additional length of the harness and wire tie (1) it in place.
